Thea Foss and Wheeler-Osgood Waterways Long Term Monitoring Plan

Preliminary Findings Memorandum – Subtidal Cap Hydrographic Survey – Year 12

REVISED PRELIMINARY FINDINGS MEMORANDUM SUBTIDAL CAP HYDROGRAPHIC SURVEY YEAR 12 MONITORING

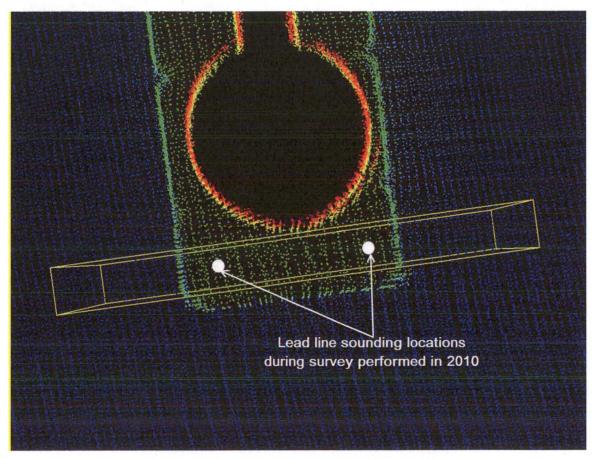
Figure 2: 3D image of 11th Street Bridge footing

During the 2010 survey a series of four lead-line soundings were taken on the south side of the eastern bridge footing of the 11th Street Bridge. The images below show the location of the lead-line soundings and a comparison of the 2010 to the 2013 data. Figure 2 is a 3D image indicating the lead line locations during the 2010 survey and yellow box showing the location of the 2D profile as depicted in figure 3. In figure 3, the 2D image is profile of the 2016 and 2018 soundings vertically exaggerated three times, the red soundings represent the 2016 survey data and the yellow soundings represent the 2018 survey data. The two sets of survey data agree within 0.04 feet at the lead-line locations of the 11th Street Bridge footing.
